**Stream Assessment Report:
Mountain View Drive
Stream Restoration Study
City of Harrisonburg, Virginia**

July 2017

Prepared for:

City of Harrisonburg
Public Works Department

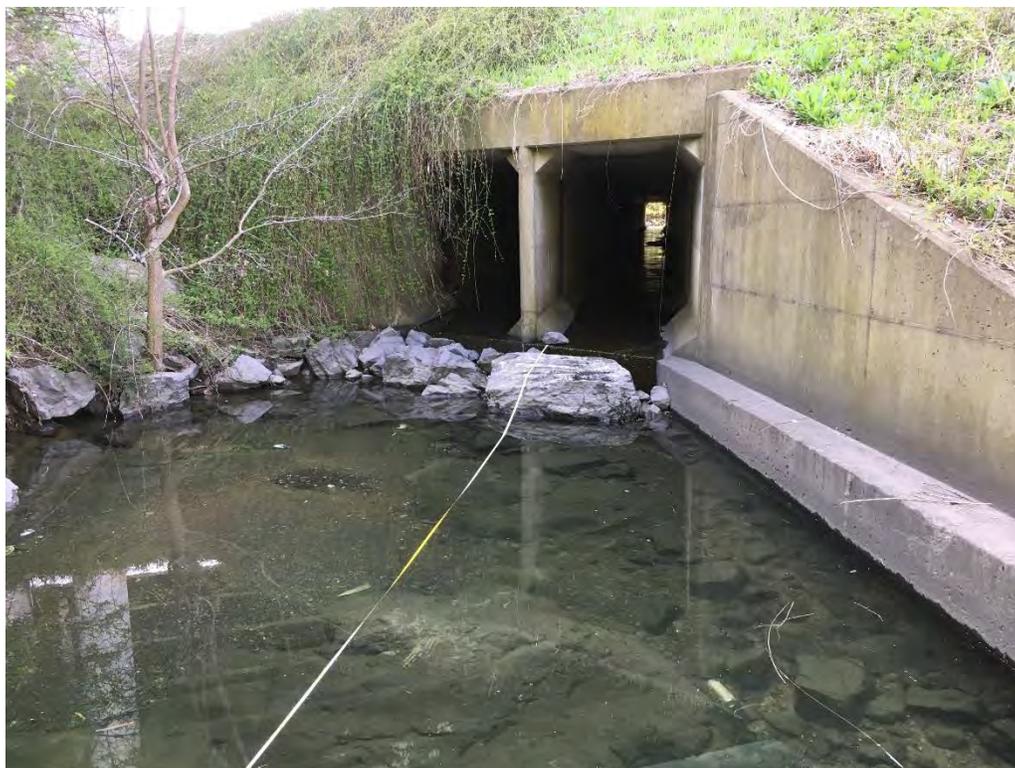
Figure 3-2 Culvert Outfall and plunge pool at the Head of Reach 1

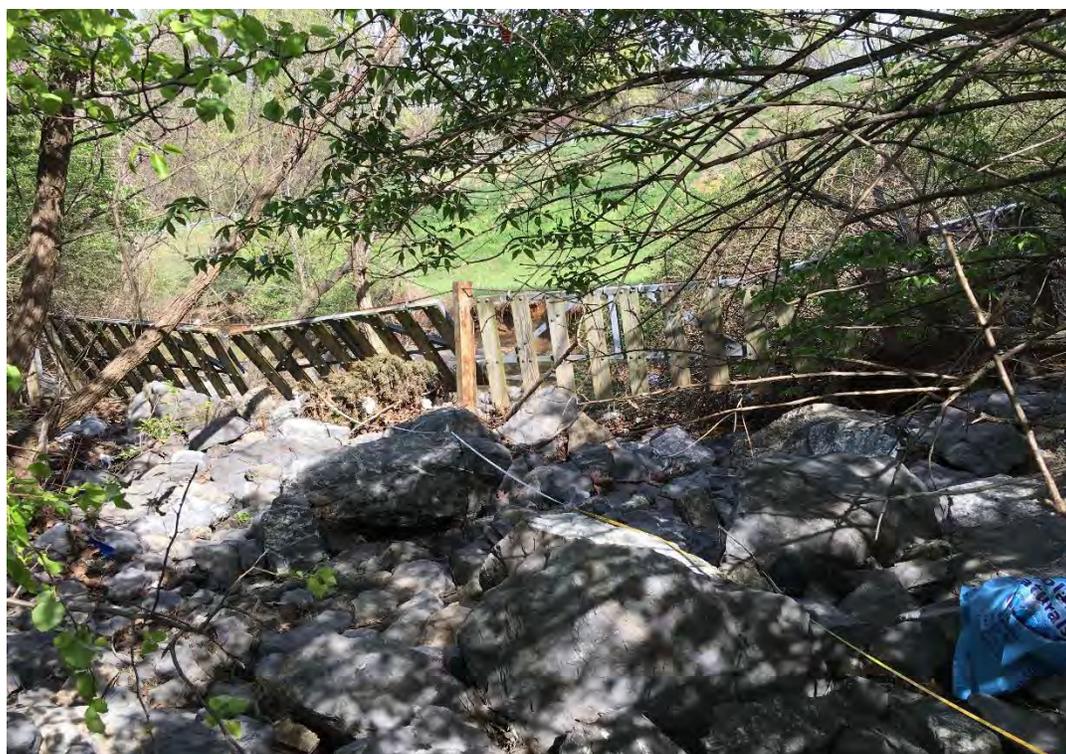
Figure 3-3 Looking Downstream Along Reach 1

(Large boulders, debris jam, cattle fence)

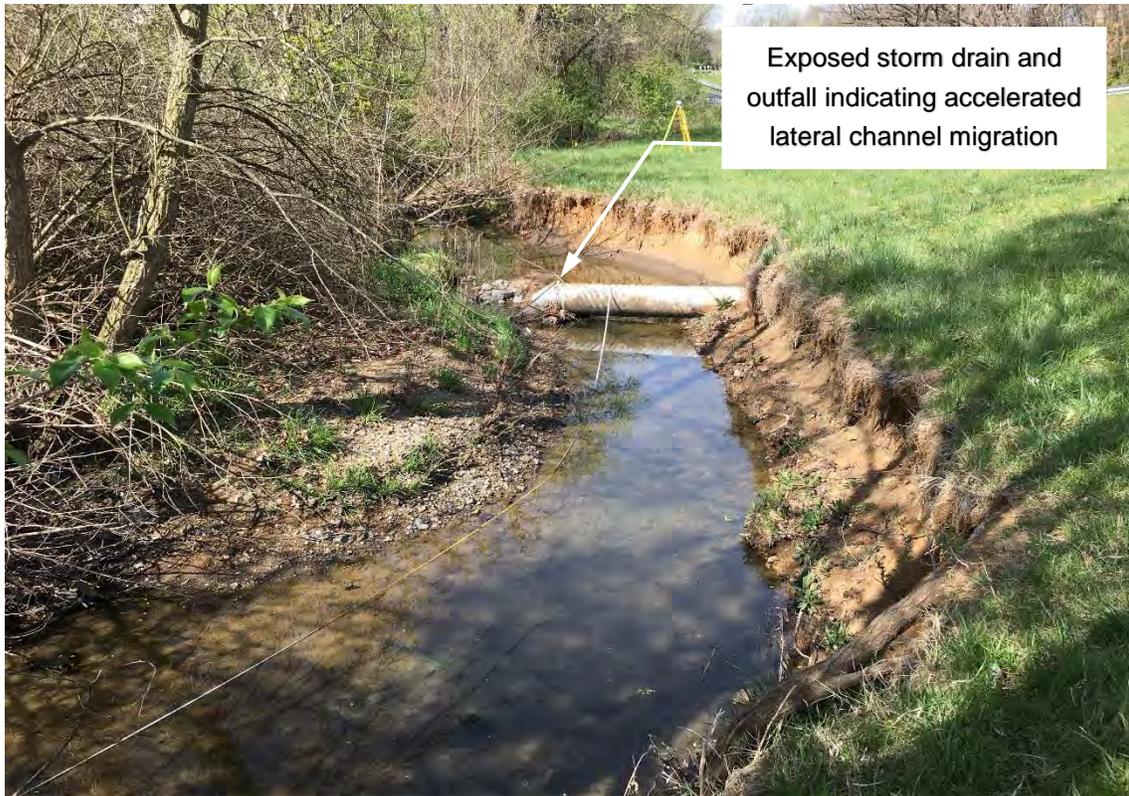
Figure 3-4 Eroded Streambank Meander Bend/exposed CMP Along Reach 1

The Concept 2 restoration plan for Reach 1 proposes a natural channel design focusing on streambank grading and thalweg alignment, as lateral instability is the primary impairment. Grade control is provided for Reach 1 by the upstream and downstream culverts. However, additional secondary grade controls may be required to establish/maintain the new thalweg alignment.

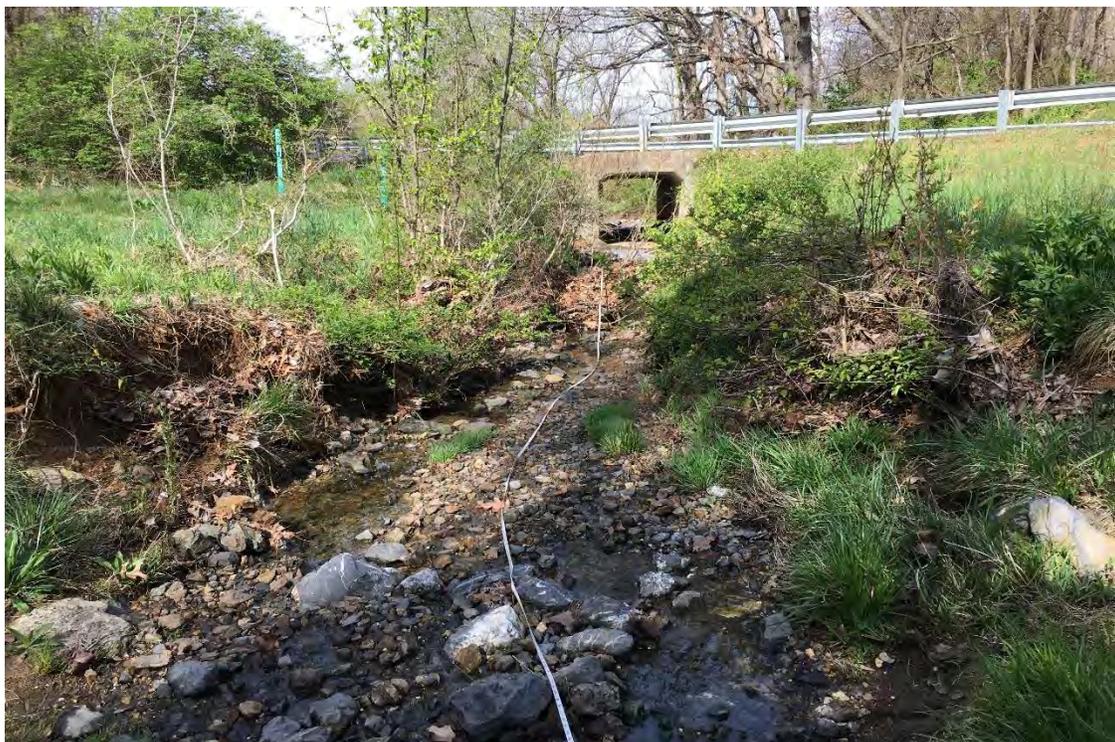
Figure 3-5 Looking downstream along a relatively stable section of Reach 1

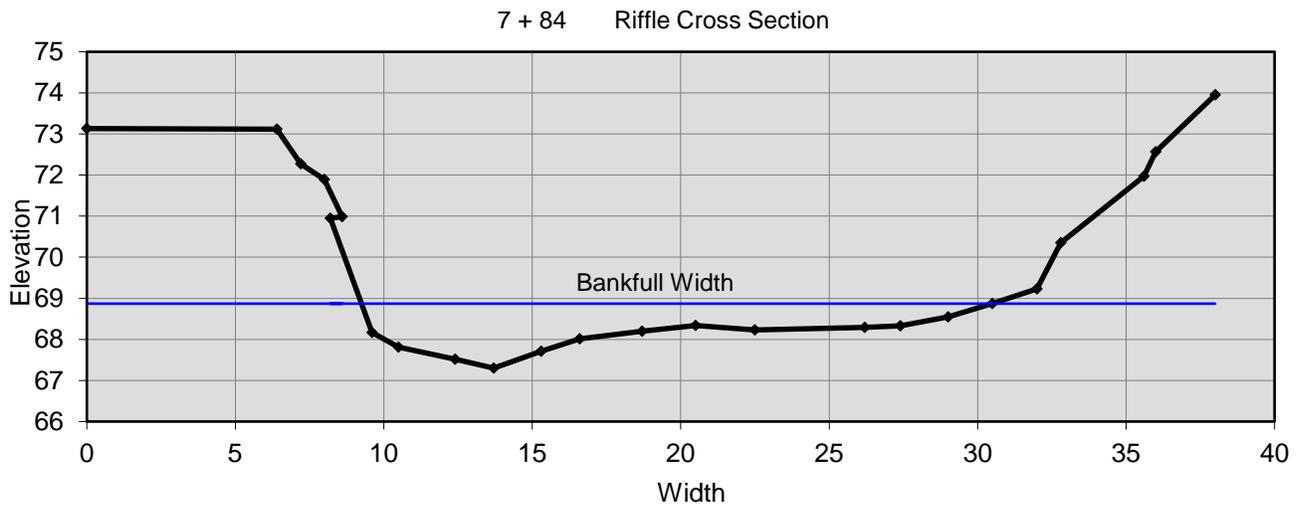
Figure 3-6 Reach 2 Riffle Cross Section

To assess the degree to which channel has incised and widened, its channel dimensions were compared to geomorphic regional equations developed by the U.S. Geological Survey (USGS) for the non-urban Ridge and Valley Physiographic Province (USGS, 2005). Table 3-1 presents the bankfull width, depth, cross sectional area, and discharge parameters derived from the field survey and the parameters for a stream with a similar drainage area derived from the regional equations. The differences from the regional equations indicates significant alteration caused by the stormwater runoff from impervious surfaces in the watershed.

In addition, the bankfull channel is confined within a much larger channel. Storm flows in excess of bankfull cannot access the floodplain and are confined within the channel. Confined flows are highly erosive and can lead to continued accelerated channel erosion. Reach 2 has significant areas of bedrock exposure along the reach invert. This bedrock is providing grade control in areas preventing channel incision and causing lateral (streambank) erosion.

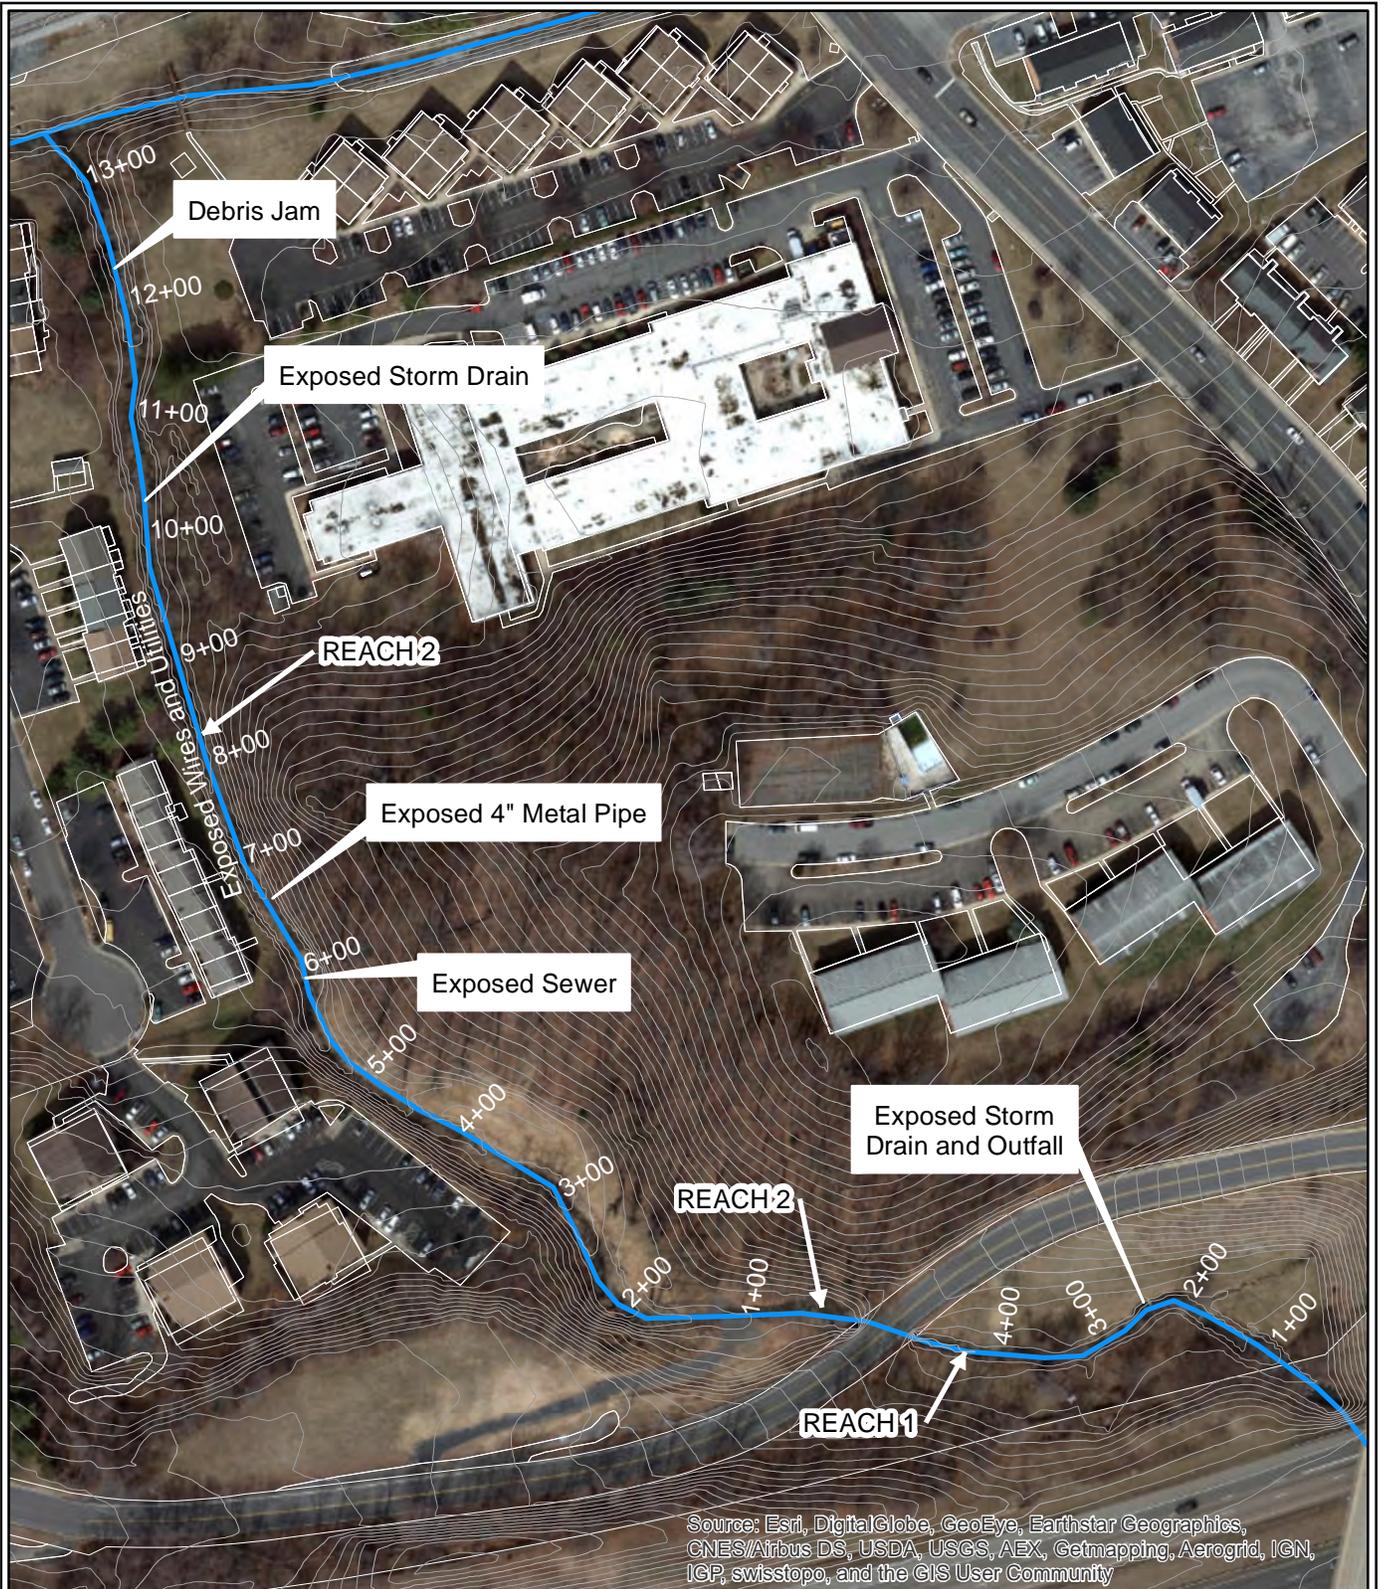
Figure 3-7 Mountain View Drive
Stream Condition Map

Reach 2 begins at the outfall of the box culvert running beneath Eastover Drive and ends at the confluence with a downstream channel. This 899-linear foot reach differs from Reach 1 in that it is deeply incised and has predominately unstable streambanks. Approximately 400 linear feet of Reach 2 is characterized by eroding streambanks in the rear yards of the single family attached houses along Mountain View Drive. This streambank erosion has exposed various utility assets. Reach 2 has an average bankfull width of 21.3 feet and a total channel width of 31.6 feet with an average slope of 3.2 %. This reach displays the attributes of a highly unstable Rosgen type “F” channel. A cross section from Reach 2 is depicted in Figure 3-6. Figure 3-7 shows an aerial view of the reach. Figures 3-8 through 3-14 depict typical conditions along Reach 2.

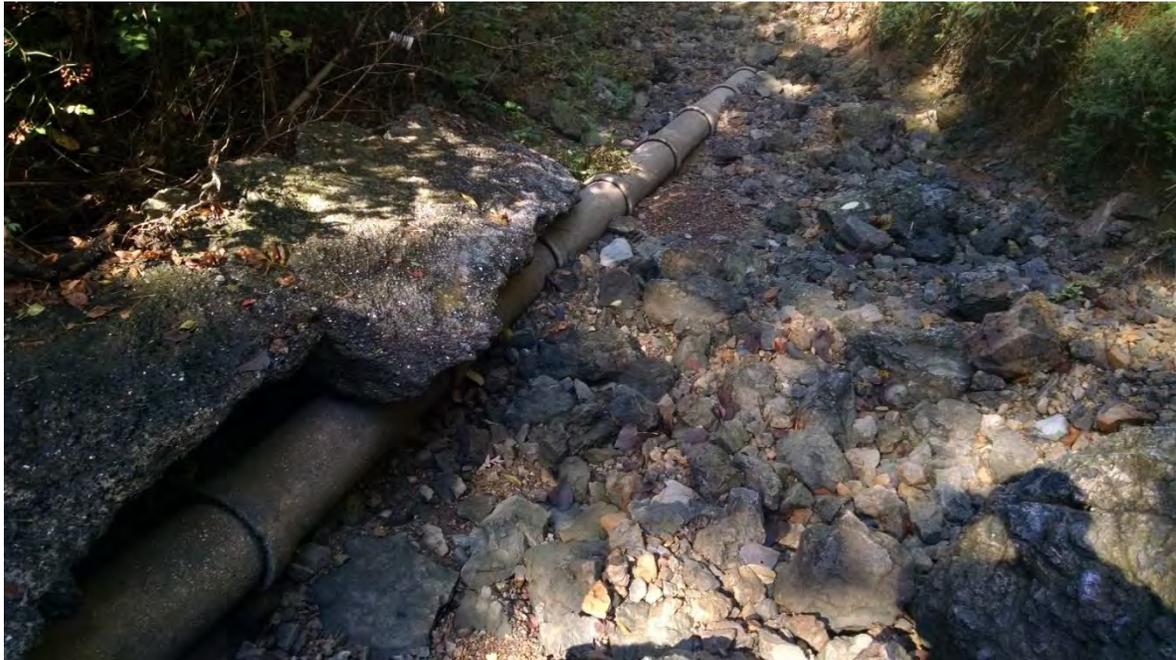
Figure 3-8 Exposed sewer line through stream section (6+00)

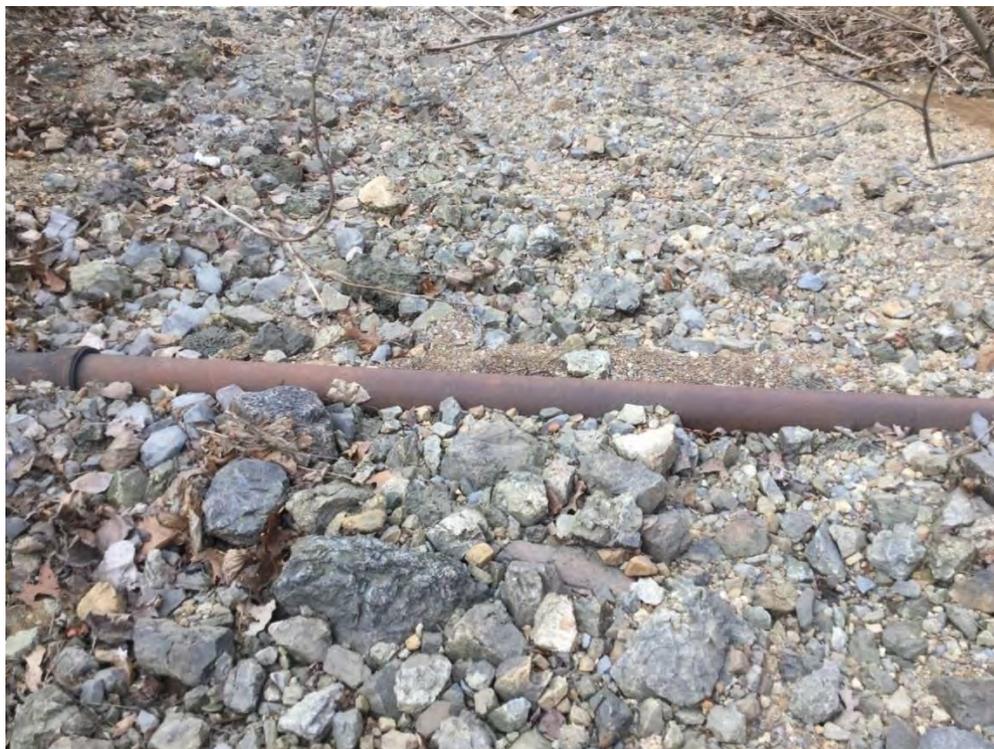
Figure 3-9 Exposed pipe in Reach 2 (6+75)

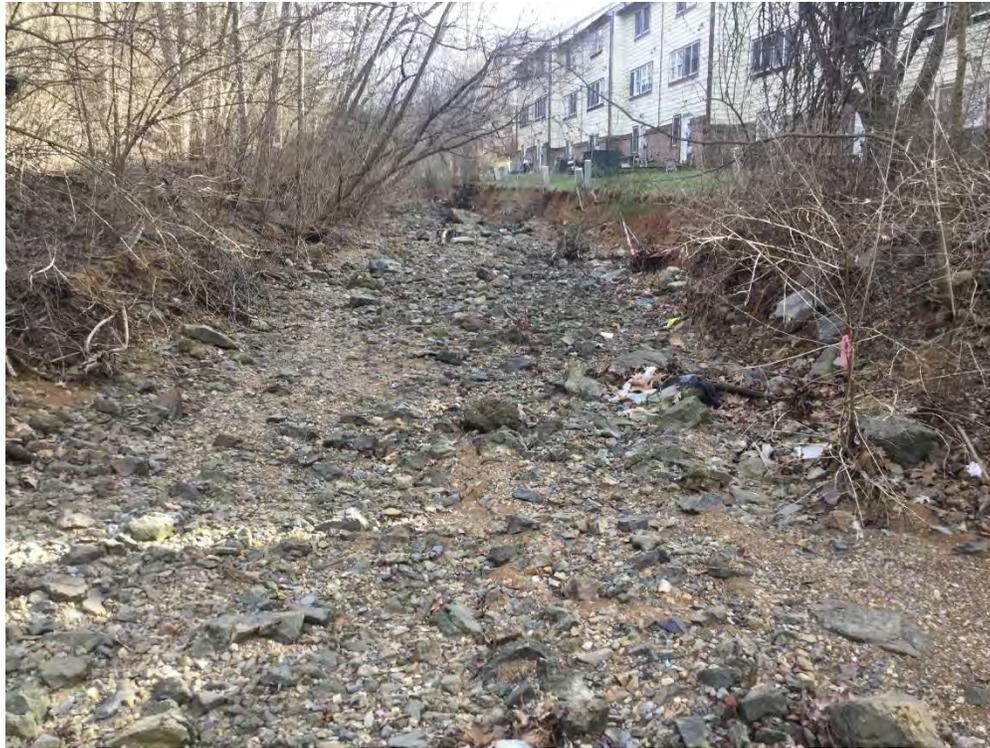
Figure 3-10 Looking up stream at eroding channel along Reach 2 (8+00)

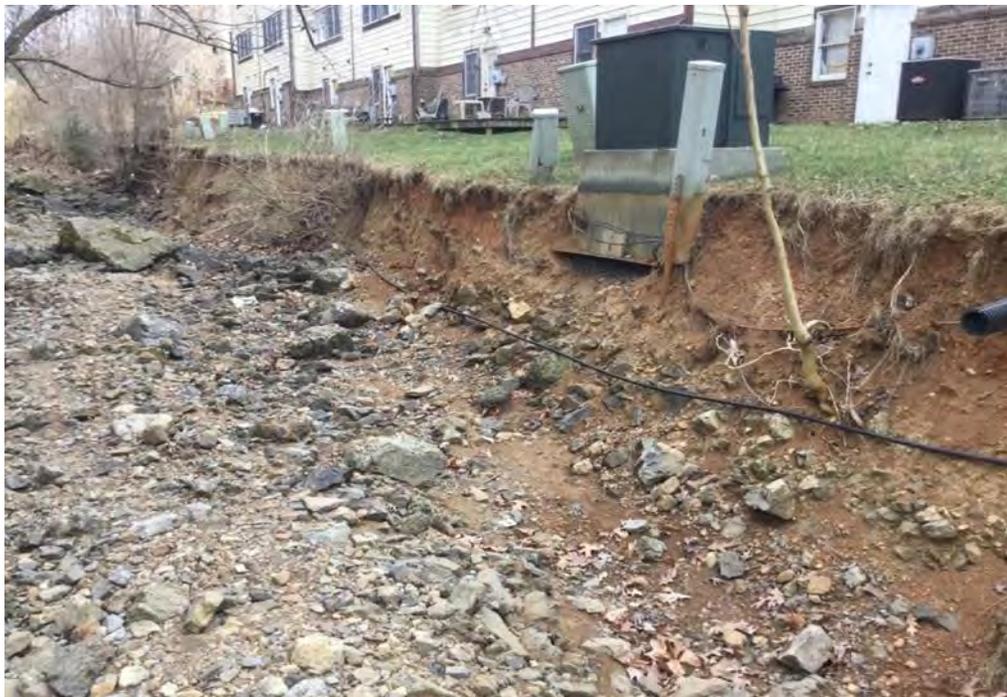
Figure 3-11 Looking upstream at eroding banks and exposed utilities along Reach 2 (7+50)

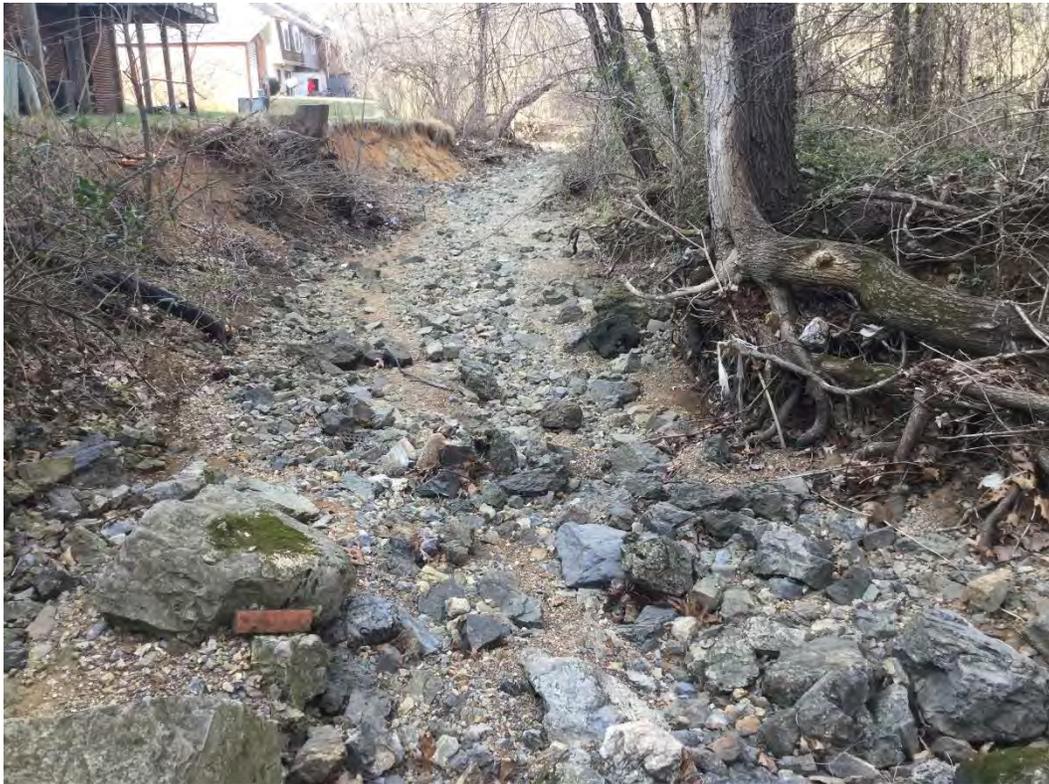
Figure 3-12 Looking downstream to eroded bank and large rocks within channel (10+00)

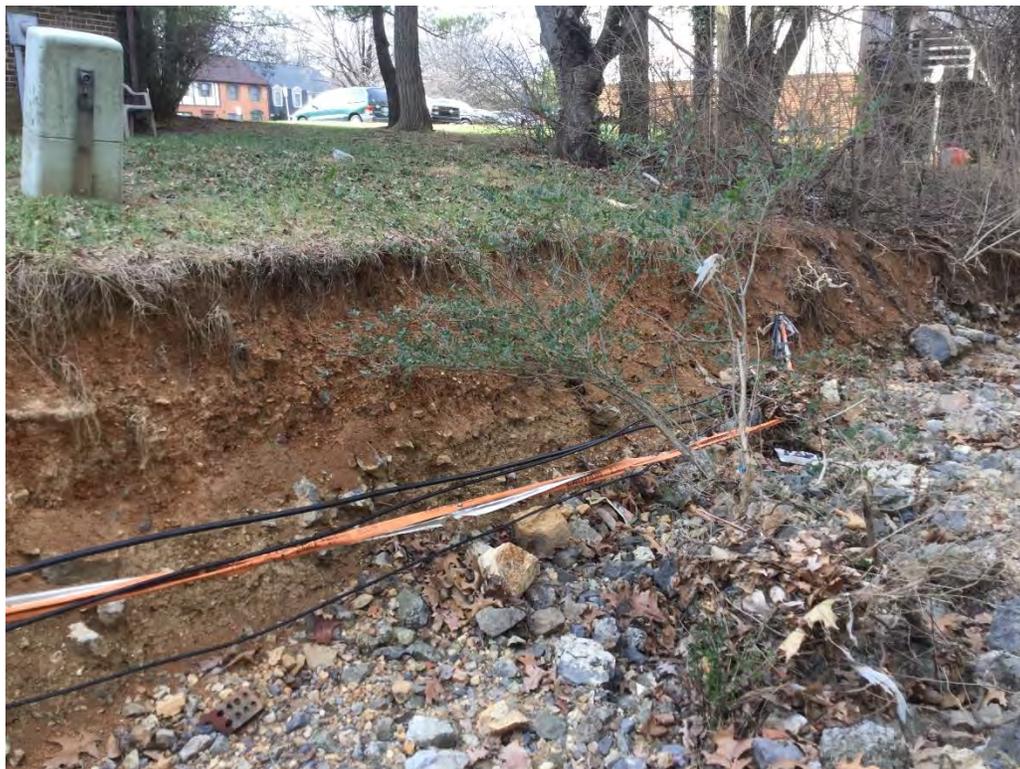
Figure 3-13 Exposed utilities along eroding bank (8+00)

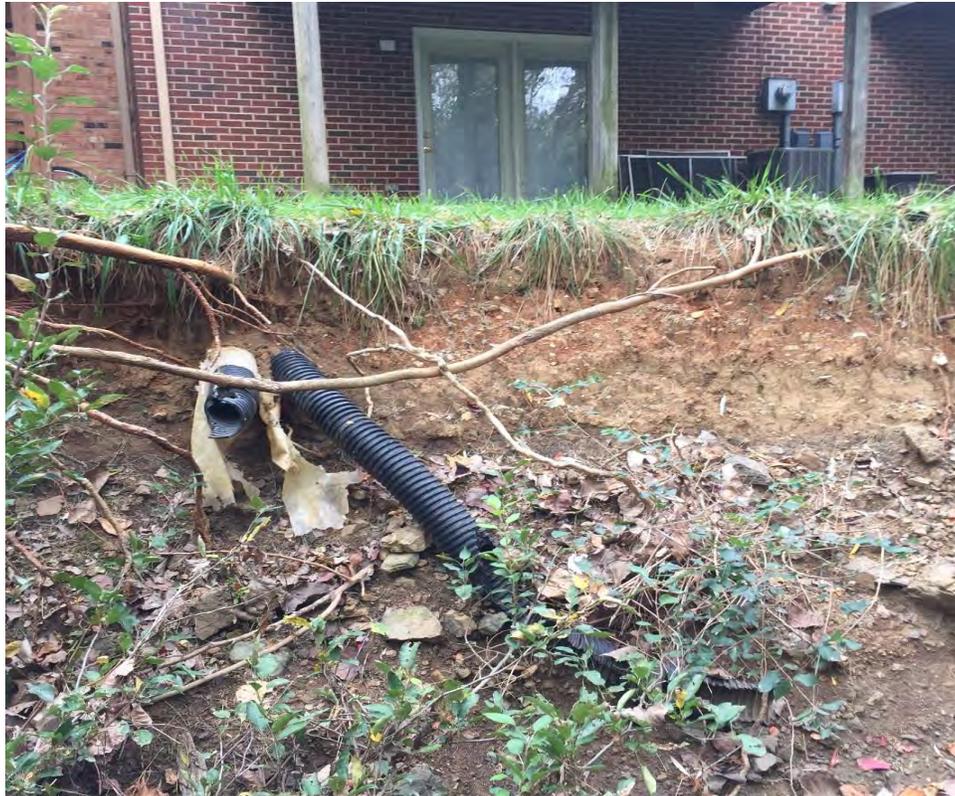
Figure 3-14 Exposed underdrain (9+50)
