**Stream Assessment Report:
Mountain View Drive
Stream Restoration Study
City of Harrisonburg, Virginia**

July 2017

Prepared for:

City of Harrisonburg
Public Works Department

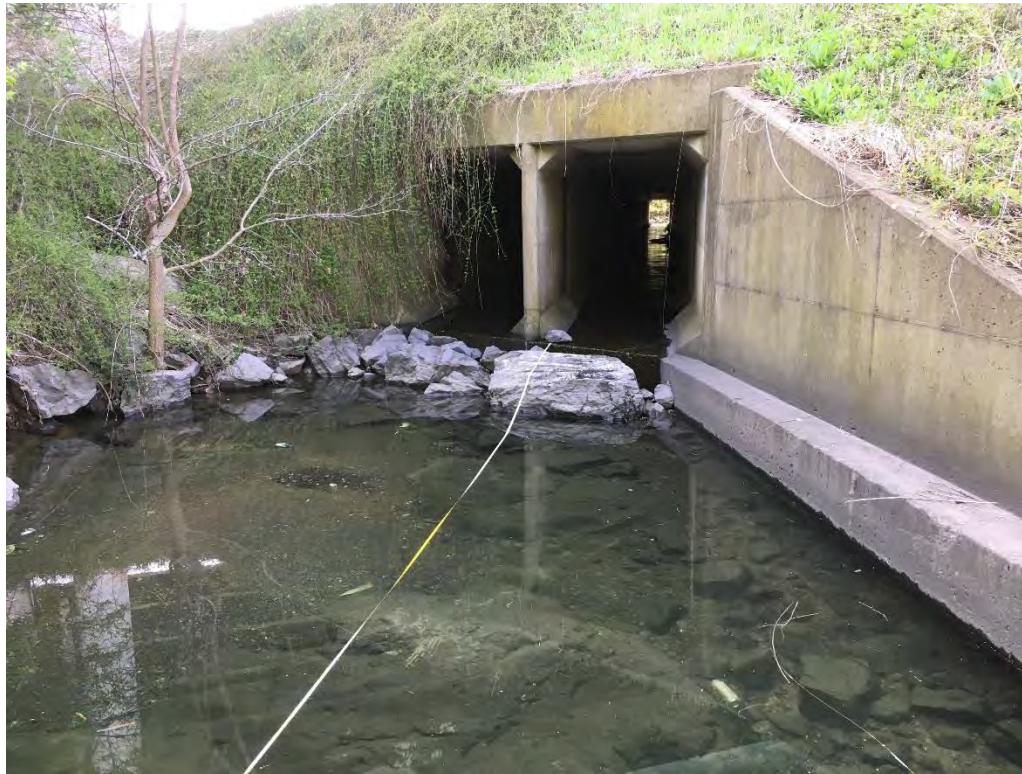
Figure 3-2 Culvert Outfall and plunge pool at the Head of Reach 1

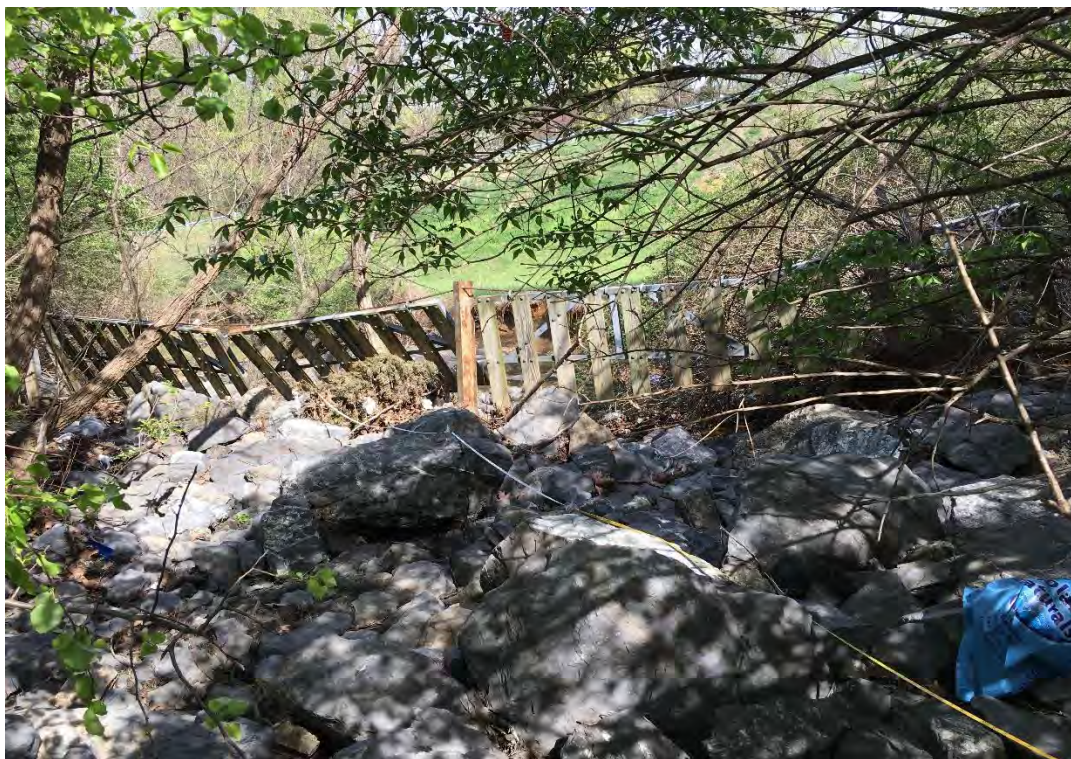
Figure 3-3 Looking Downstream Along Reach 1

(Large boulders, debris jam, cattle fence)

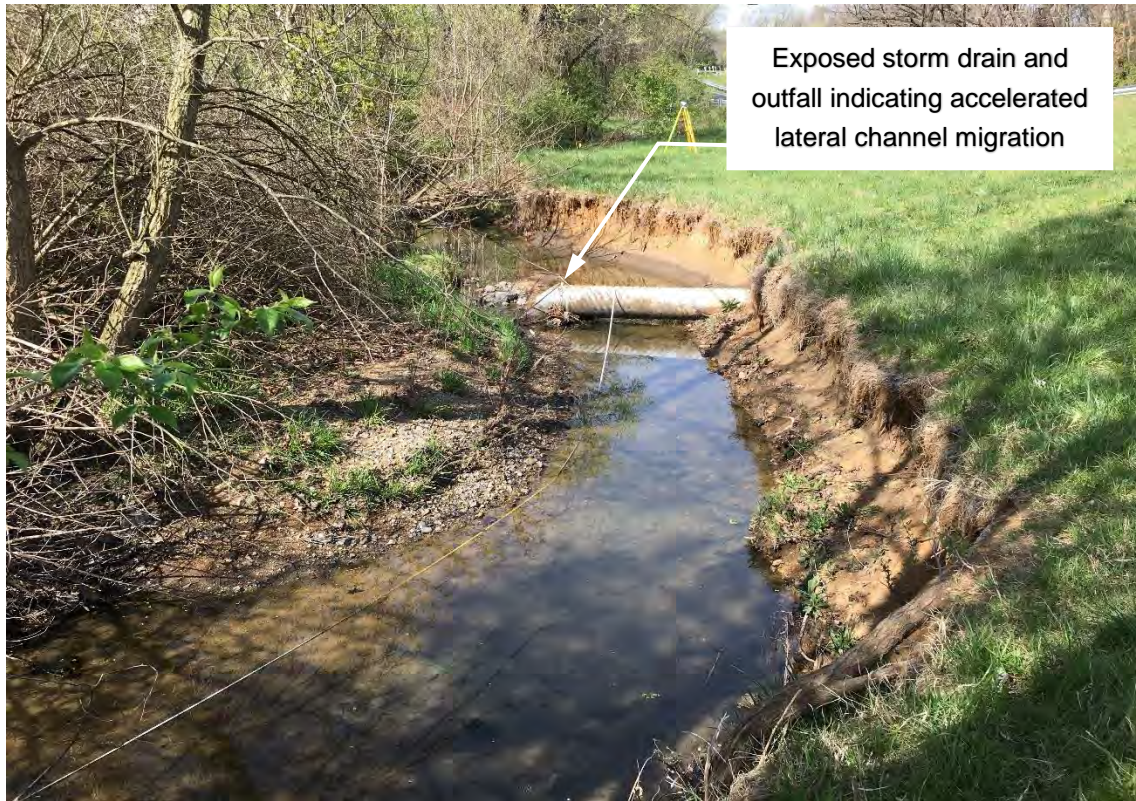
Figure 3-4 Eroded Streambank Meander Bend/exposed CMP Along Reach 1

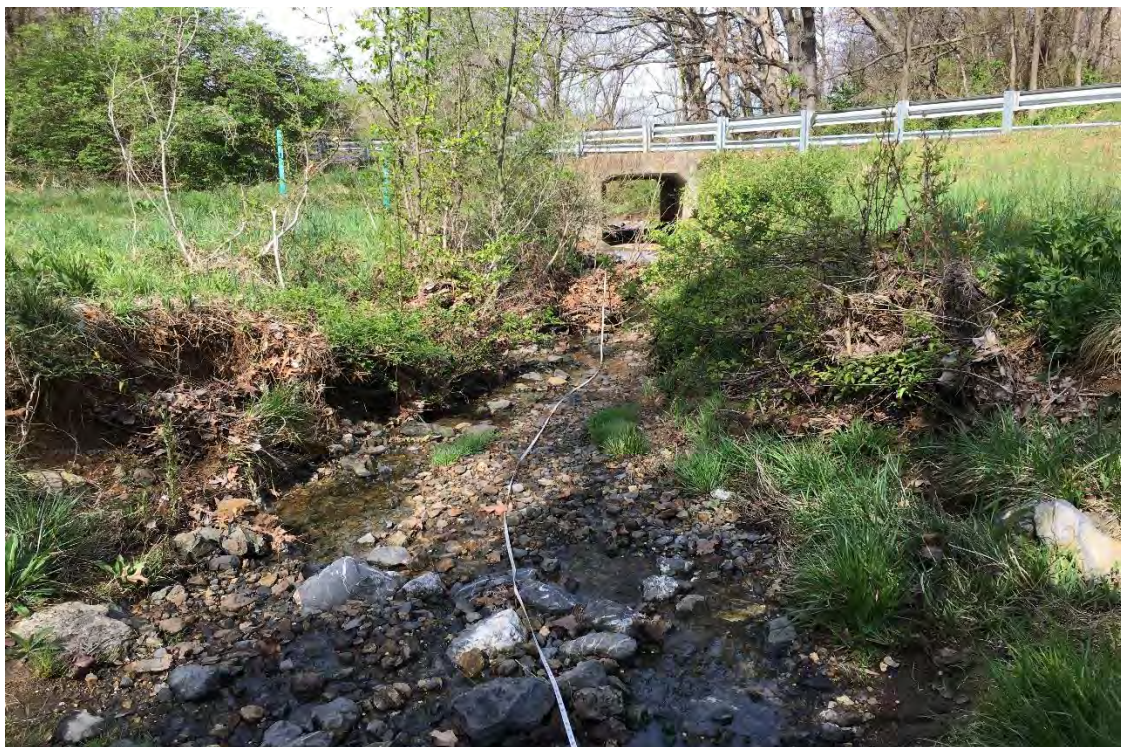
Figure 3-5 Looking downstream along a relatively stable section of Reach 1

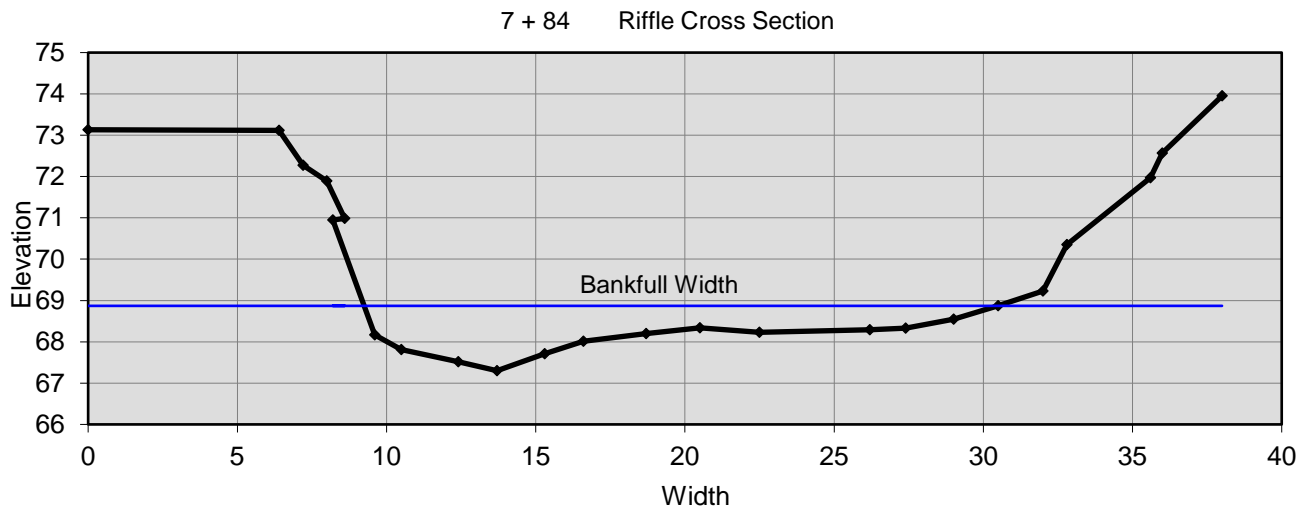
Figure 3-6 Reach 2 Riffle Cross Section

To assess the degree to which channel has incised and widened, its channel dimensions were compared to geomorphic regional equations developed by the U.S. Geological Survey (USGS) for the non-urban Ridge and Valley Physiographic Province (USGS, 2005). Table 3-1 presents the bankfull width, depth, cross sectional area, and discharge parameters derived from the field survey and the parameters for a stream with a similar drainage area derived from the regional equations. The differences from the regional equations indicates significant alteration caused by the stormwater runoff from impervious surfaces in the watershed.

In addition, the bankfull channel is confined within a much larger channel. Storm flows in excess of bankfull cannot access the floodplain and are confined within the channel. Confined flows are highly erosive and can lead to continued accelerated channel erosion. Reach 2 has significant areas of bedrock exposure along the reach invert. This bedrock is providing grade control in areas preventing channel incision and causing lateral (streambank) erosion.

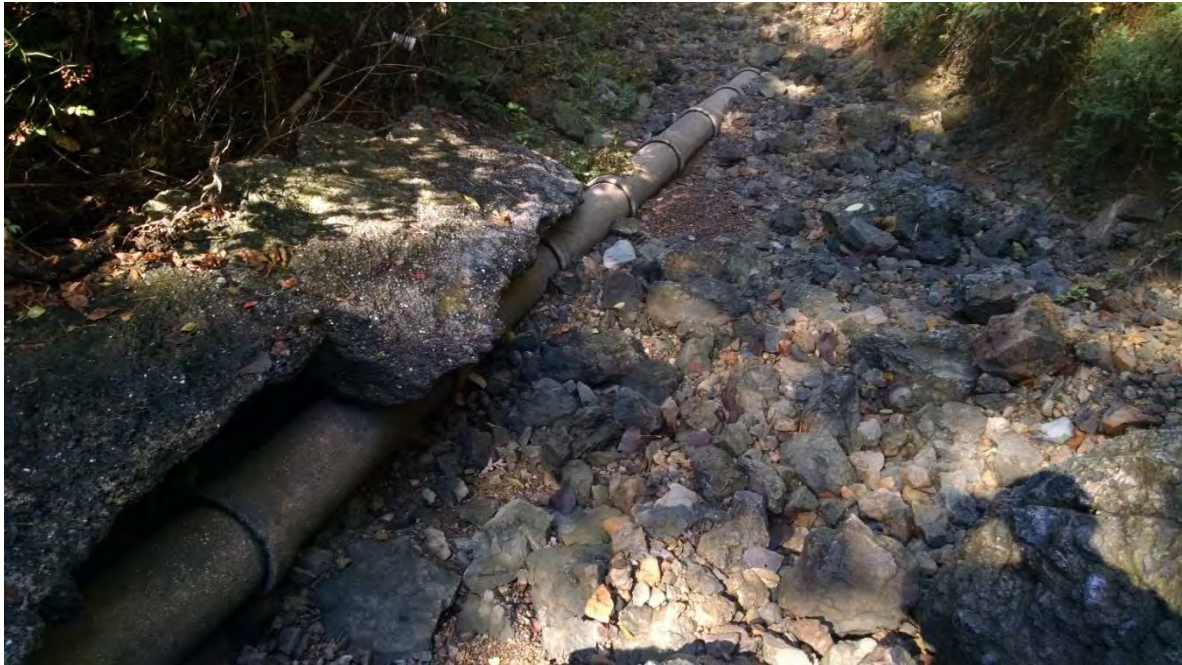
Figure 3-8 Exposed sewer line through stream section (6+00)

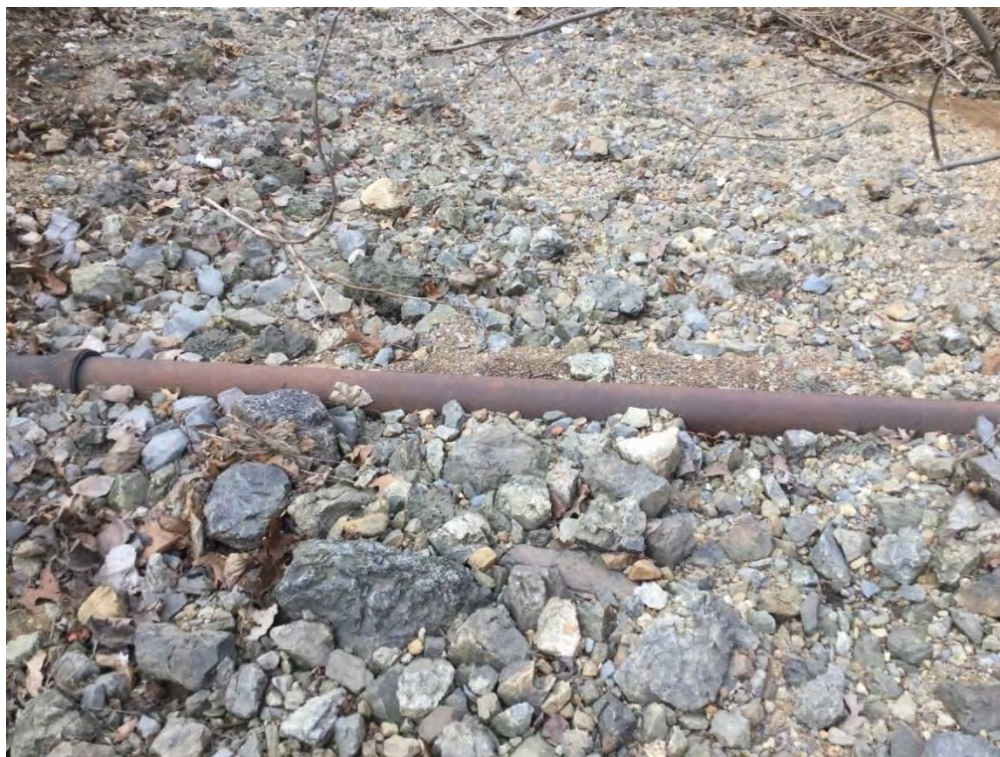
Figure 3-9 Exposed pipe in Reach 2 (6+75)

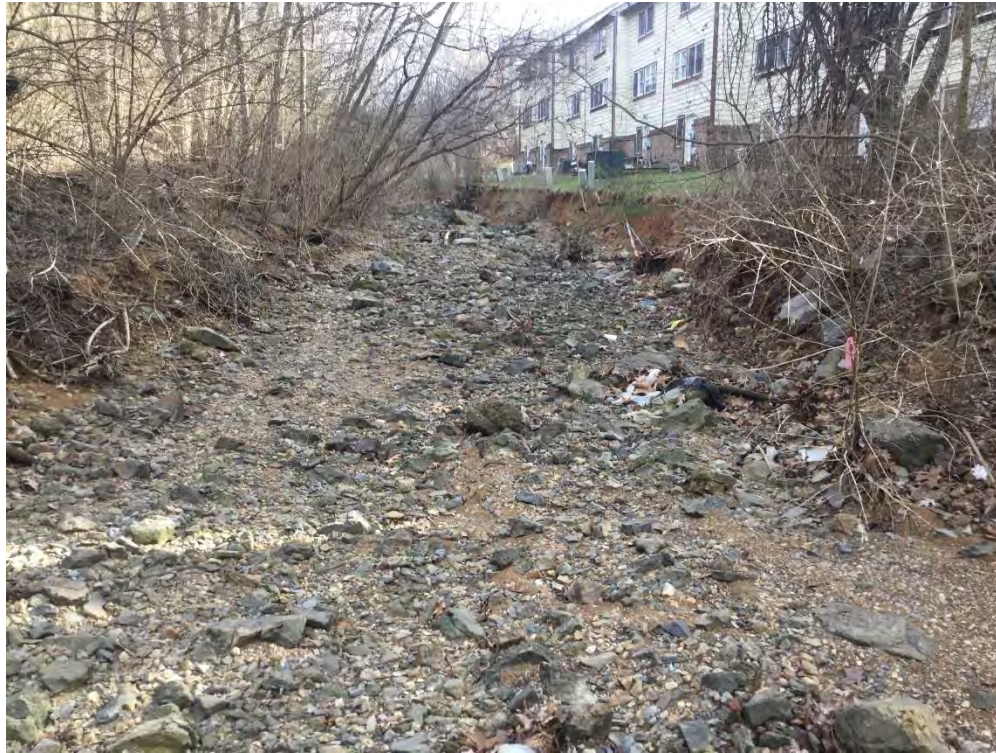
Figure 3-10 Looking up stream at eroding channel along Reach 2 (8+00)

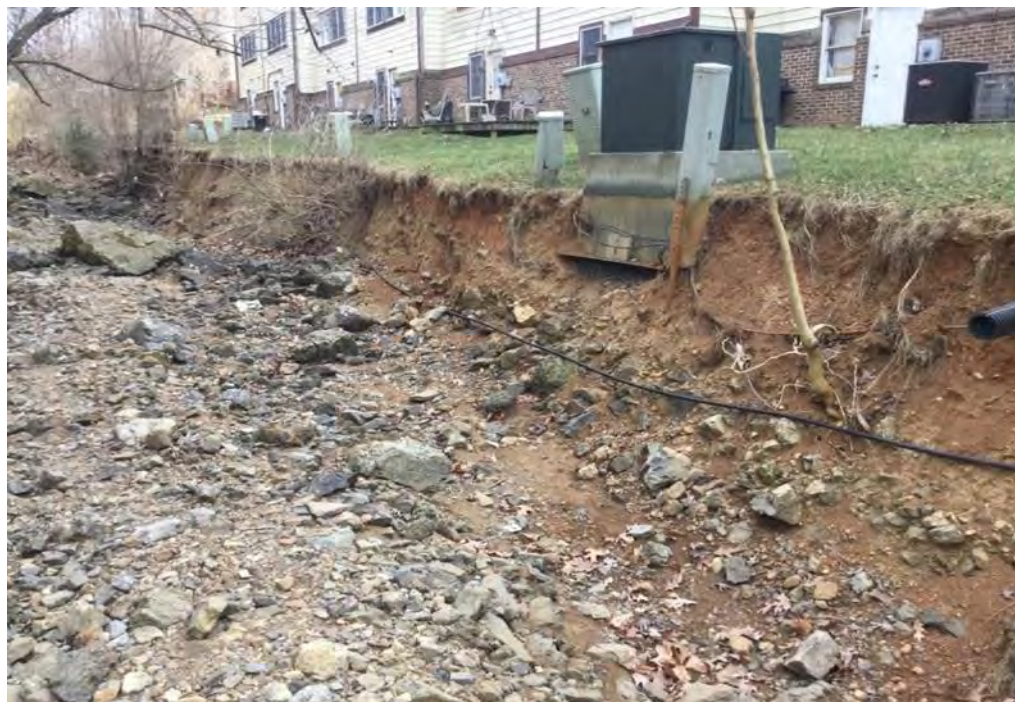
Figure 3-11 Looking upstream at eroding banks and exposed utilities along Reach 2 (7+50)

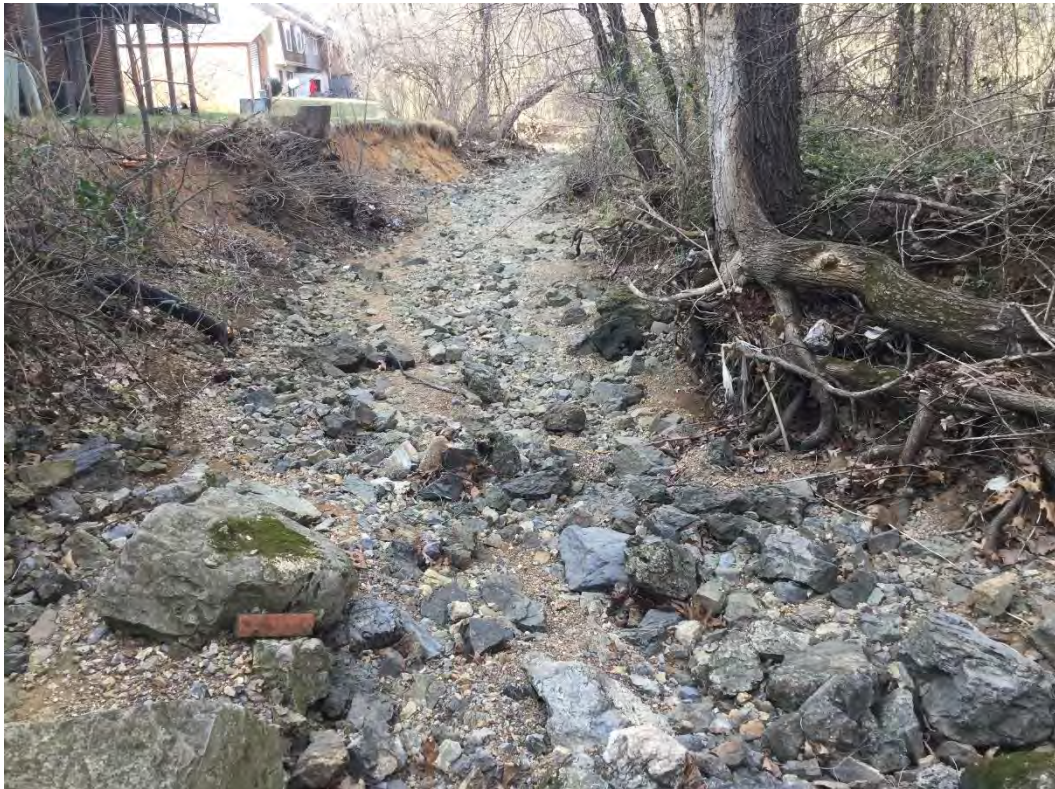
Figure 3-12 Looking downstream to eroded bank and large rocks within channel (10+00)

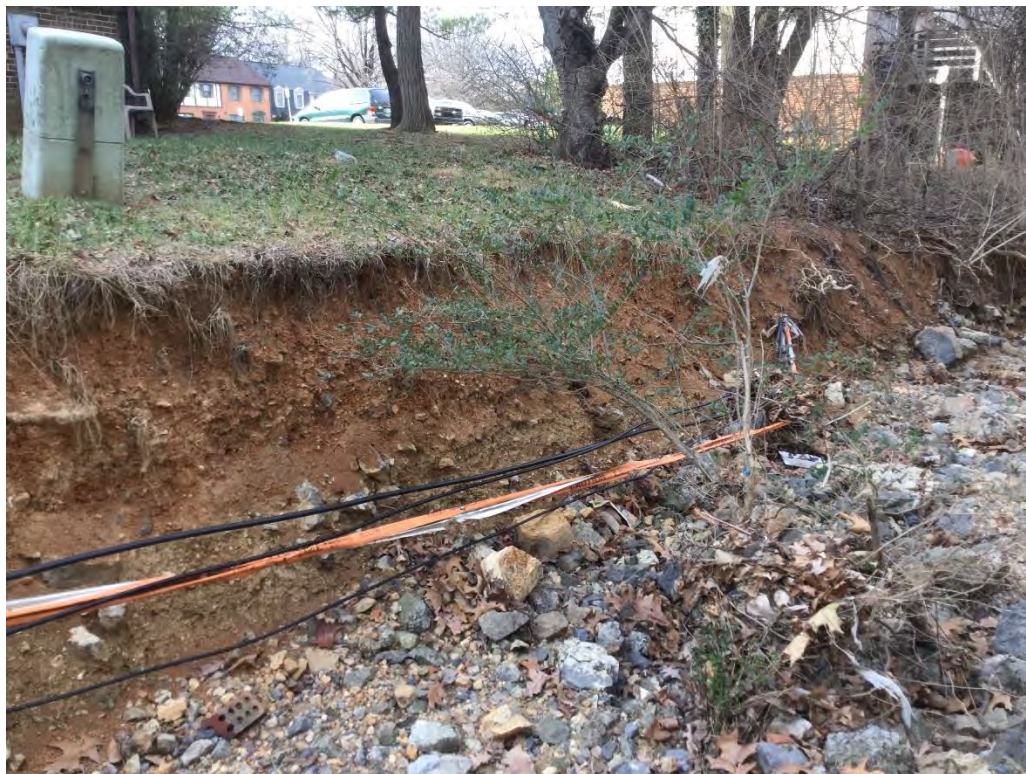
Figure 3-13 Exposed utilities along eroding bank (8+00)

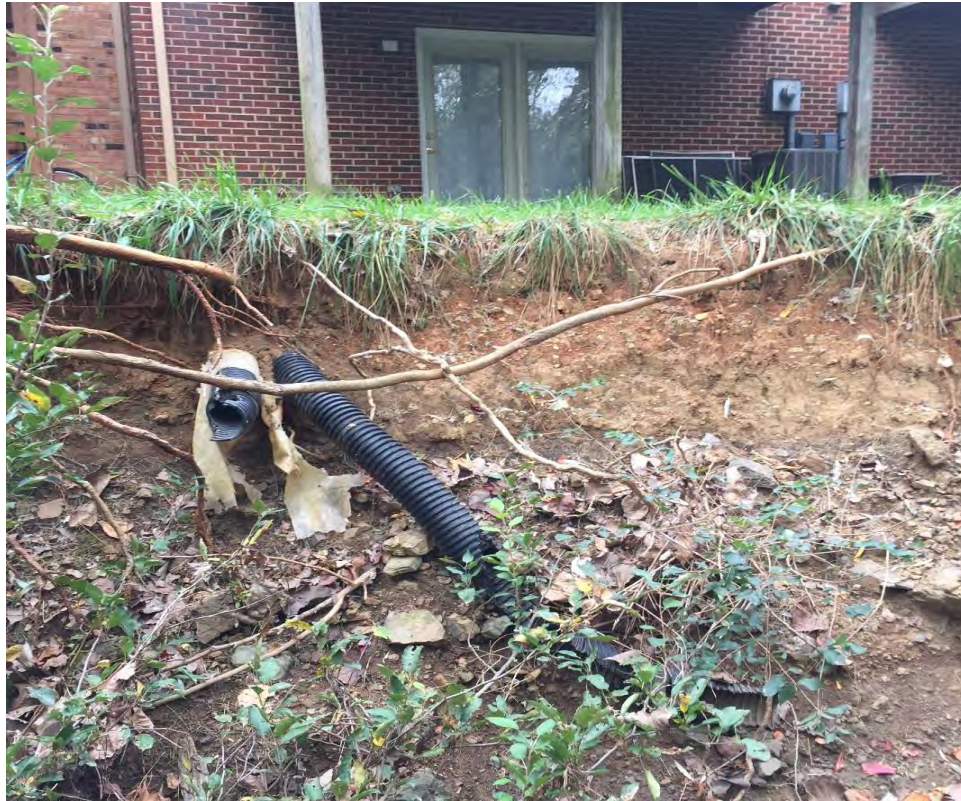
Figure 3-14 Exposed underdrain (9+50)
