## MEMORANDUM OF UNDERSTANDING

THOMAS HARRISON HOUSE  
 PROJECT # 1403

Thomas Harrison House  
Architectural Survey & Assessment  
Report of Findings

January 27, 2012

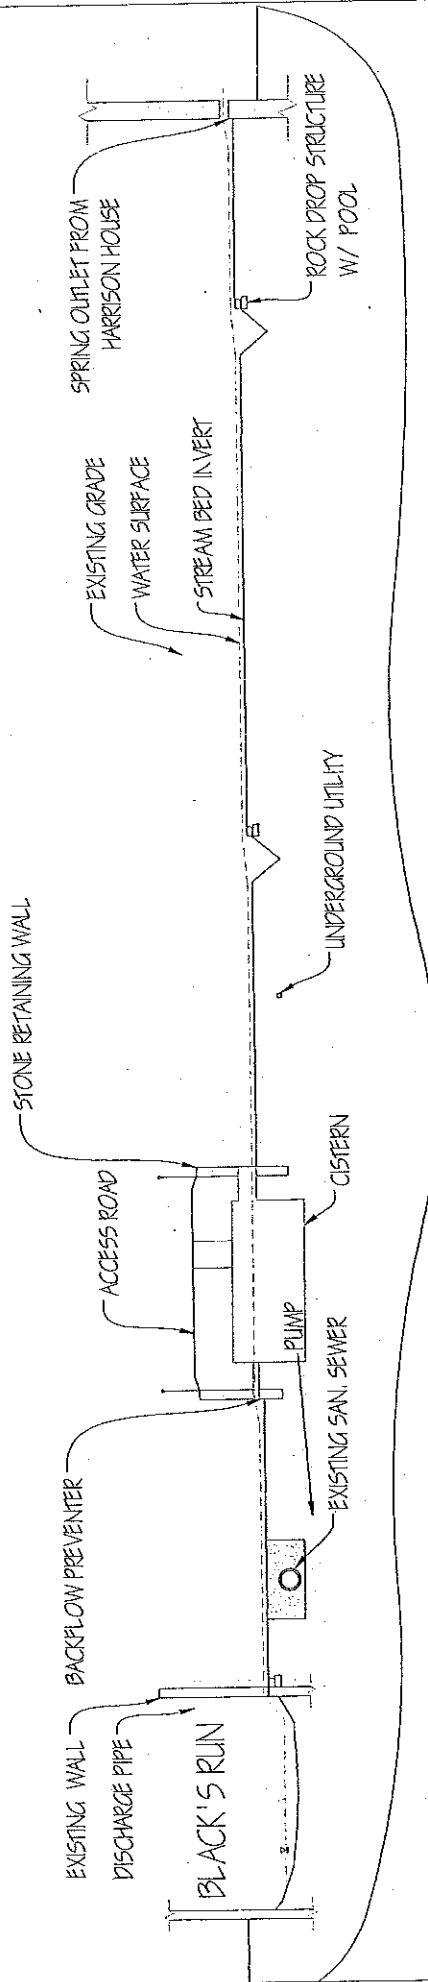
# Harrison House Schematic - Profile A-A

The historic restoration of the Harrison House includes the daylighting of a spring fed channel which originates in the cellar of the historic structure. The spring channel currently discharges through the foundation wall to a pipe which drains to the sanitary sewer system. This condition results in the regular reversal of flow from the sanitary sewer which subsequently discharges sewage and stormwater into the cellar of the Harrison House. The proposed restoration plan would disconnect the spring flow from the sanitary sewer and return the flow to an open channel that would discharge to Black's Run.

The profile below depicts the route the daylighted stream would take. First the stream would flow through the existing outlet in the foundation and drop in grade at a minimum of 0.5% slope as it makes its way to Black's Run. The stream and any stormwater runoff will drain to a culvert and cistern located under the access road. This cistern can be emptied using an internal pump and by opening a valve that will release flow to Black's Run, or it can be used for irrigation purposes. If the cistern is full, the stream will continue its course and flow under the access road and return to an open channel condition. The end of the culvert exiting the cistern as well as the discharge pipe from the cistern will have a backflow preventer installed, which will allow flow to move out (towards Black's Run) but not back in during storm events. This will prevent the garden area and Harrison House from being flooded when Black's Run rises in elevation. After discharging from the culvert, the stream will meander to its confluence with Black's Run.

As a means to address this condition design efforts were initiated to develop a water management system to disconnect the lateral from the sewer main, redirect the spring flow into Black's Run and provide a flood management system to prevent water infiltration into the basement from Black's Run during periods of heavy rainfall when the stream rises. As the difference in elevation from the spring to Black's Run is only 12"-15" it would not take a significant rise in the stream's water level to create a backup of water in the basement through the connecting discharge line. It is also necessary to manage the outflow of water from the spring, which also increases with rainfall. This creates two sources of water that must be suitably directed and controlled.

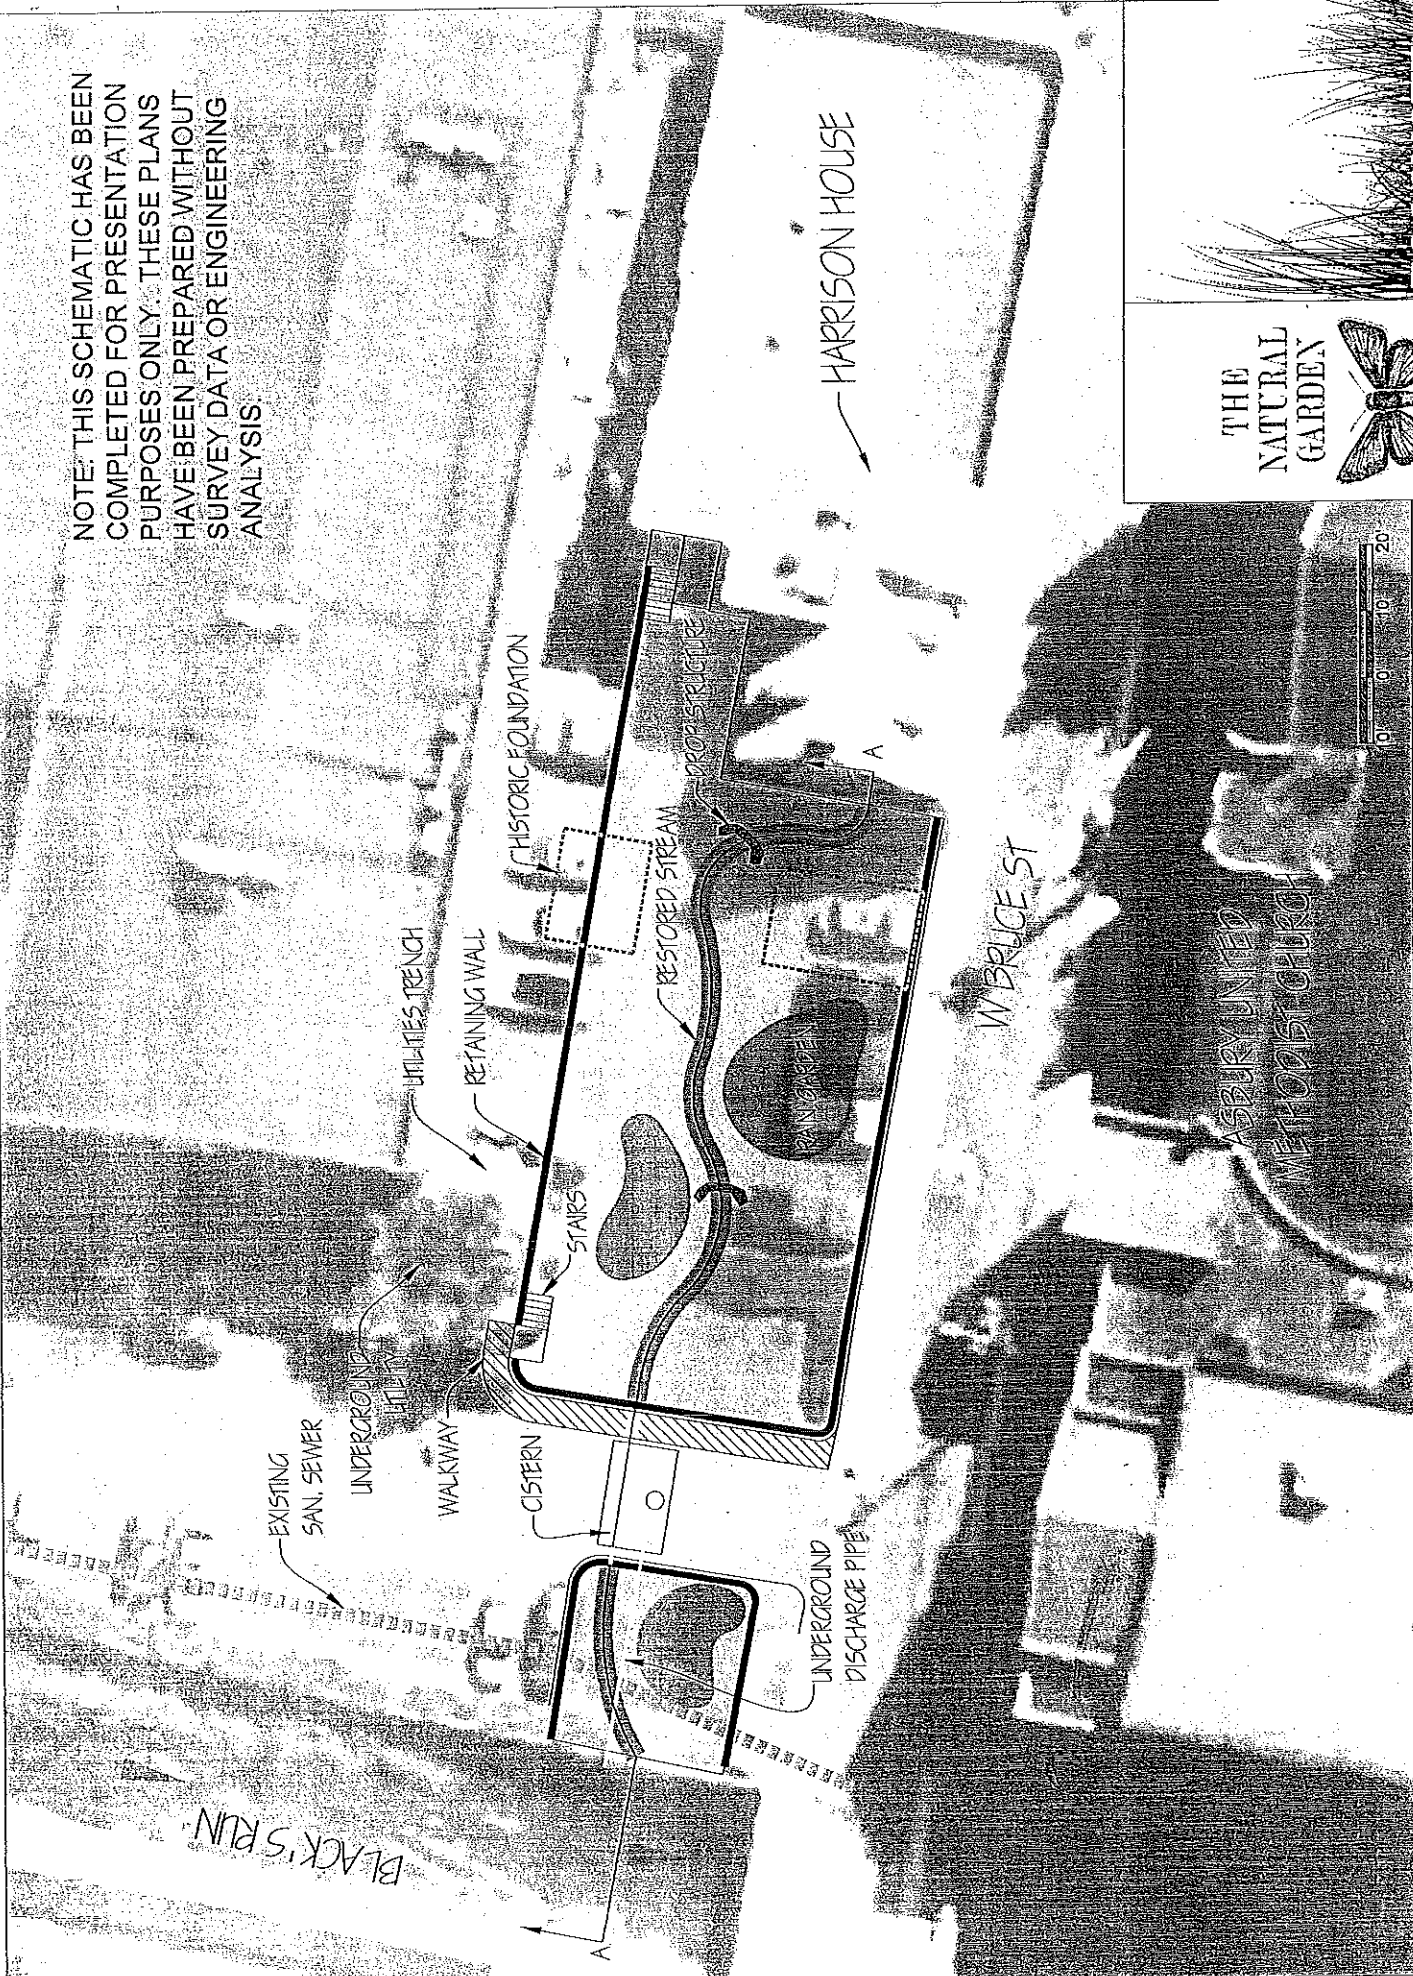
# Harrison House Schematic - Plan View

The attached design provides an overview of the water management system and the larger garden concept. Because of the nature of the sewage backup and the need to sanitize the basement prior to any work beginning in that space, it is currently proposed that the water management system will need to be installed before the larger archaeological excavations could begin, so this is intended to serve as a general concept design until a number of the outstanding archaeological issues are identified and resolved and the design is reviewed by the steering committee for any possible changes.
