**Stream Assessment Report:
Mountain View Drive
Stream Restoration Study
City of Harrisonburg, Virginia**

July 2017

Prepared for:

City of Harrisonburg
Public Works Department

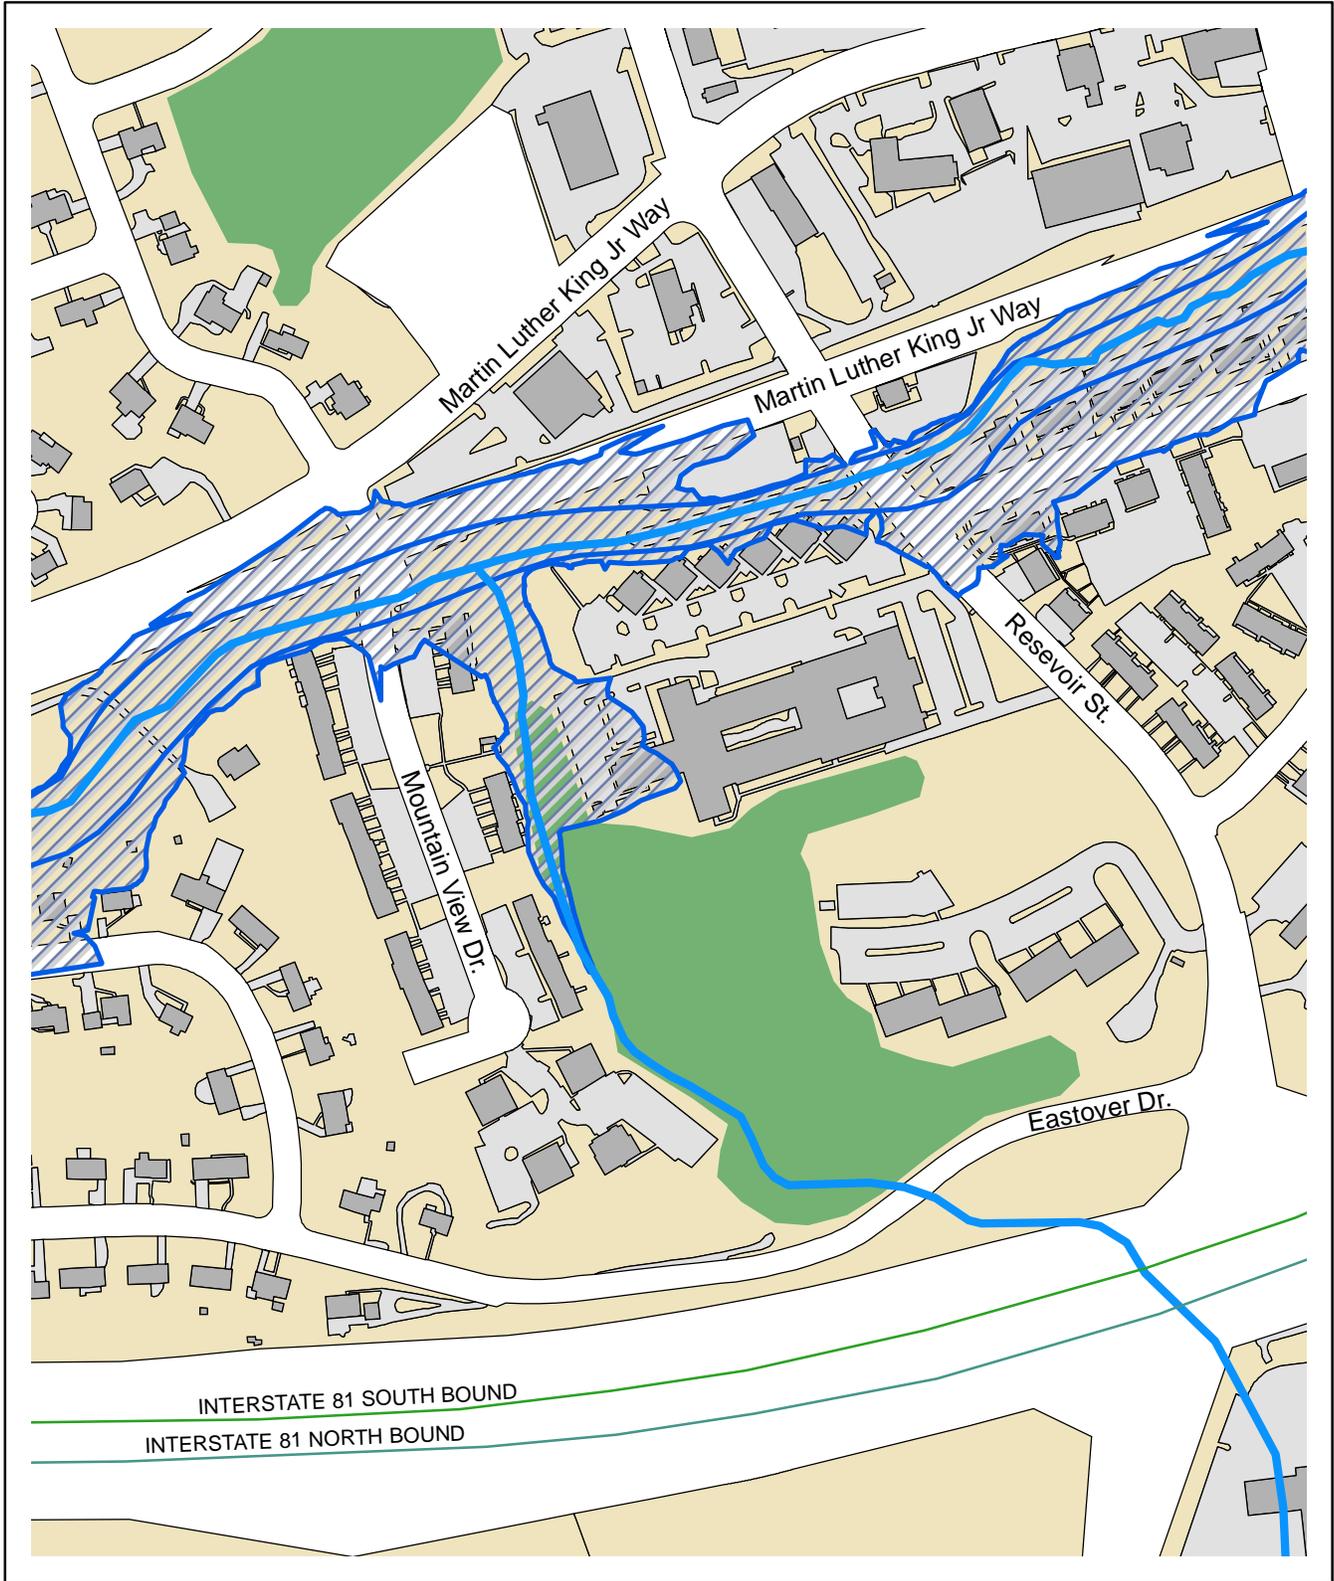
Figure 2-4 Mountain View Drive
FEMA 100-Year Floodplain Map

The Federal Emergency Management Agency (FEMA) Flood Insurance Rate Map (Figure 2-4) for the area indicates that a portion of the study area lies within a FEMA mapped floodplain. The mapped floodplain covers approximately 45% of Reach 2. If restoration activities occur within the mapped 100-year floodplain, FEMA coordination will be necessary.
