**Stream Assessment Report:
Mountain View Drive
Stream Restoration Study
City of Harrisonburg, Virginia**

July 2017

Prepared for:

City of Harrisonburg
Public Works Department

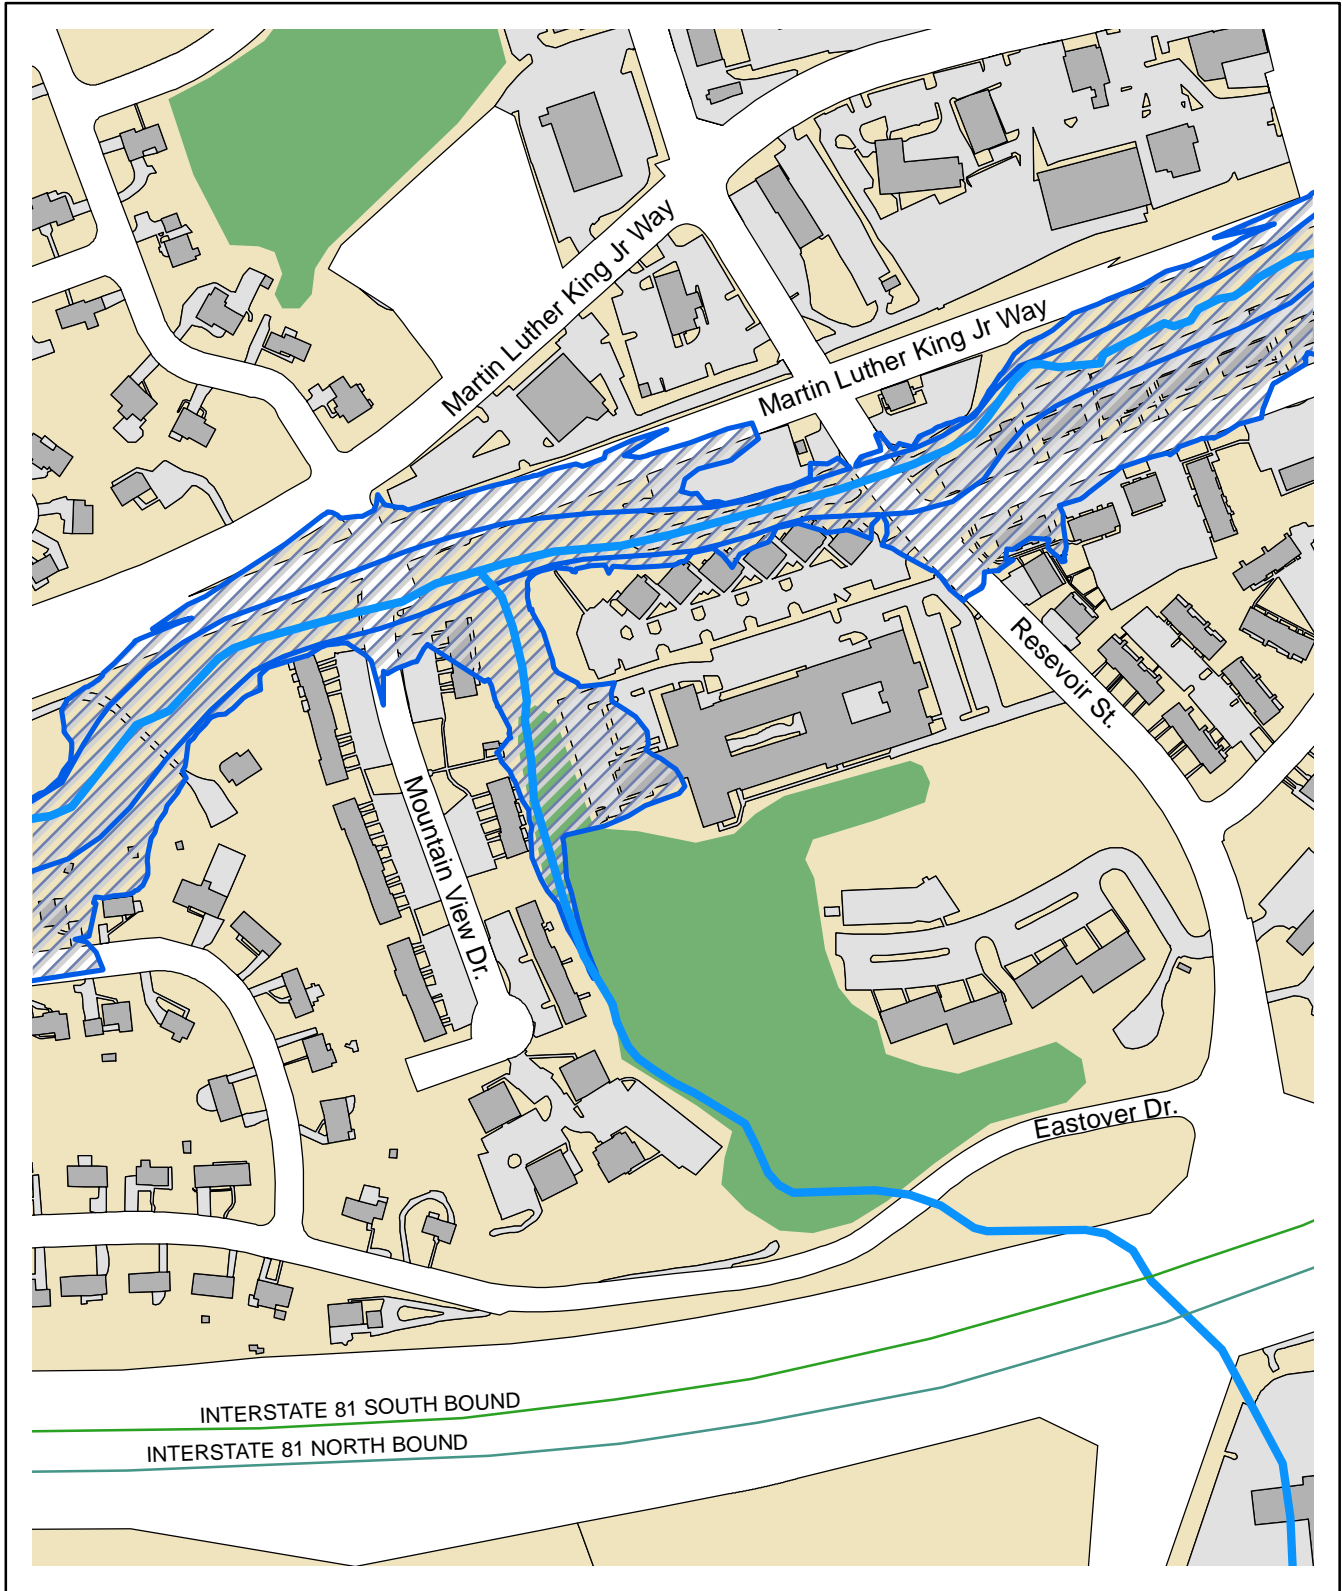
Figure 2-4 Mountain View Drive
FEMA 100-Year Floodplain Map

The Federal Emergency Management Agency (FEMA) Flood Insurance Rate Map (Figure 2-4) for the area indicates that a portion of the study area lies within a FEMA mapped floodplain. The mapped floodplain covers approximately 45% of Reach 2. If restoration activities occur within the mapped 100-year floodplain, FEMA coordination will be necessary.

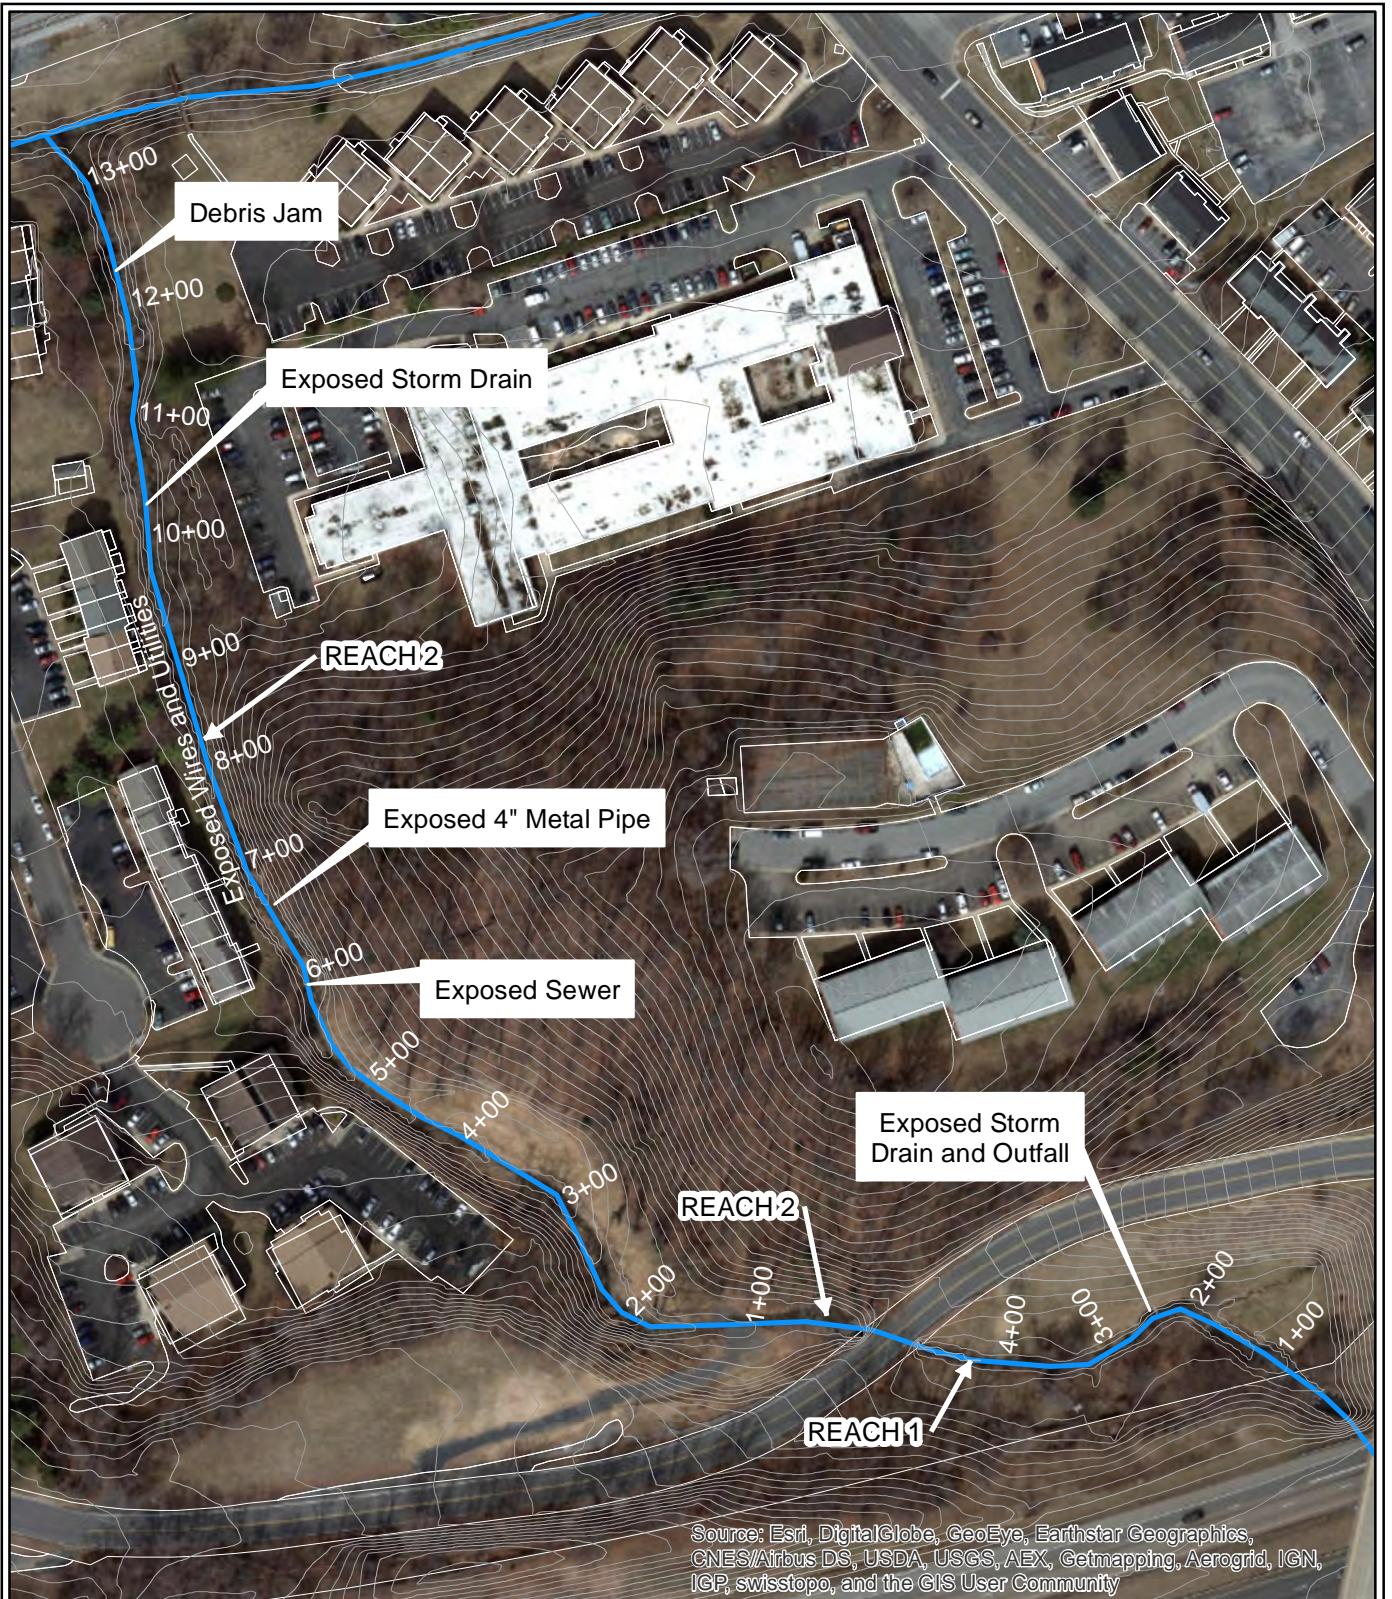
Figure 3-7 Mountain View Drive
Stream Condition Map

Reach 2 begins at the outfall of the box culvert running beneath Eastover Drive and ends at the confluence with a downstream channel. This 899-linear foot reach differs from Reach 1 in that it is deeply incised and has predominately unstable streambanks. Approximately 400 linear feet of Reach 2 is characterized by eroding streambanks in the rear yards of the single family attached houses along Mountain View Drive. This streambank erosion has exposed various utility assets. Reach 2 has an average bankfull width of 21.3 feet and a total channel width of 31.6 feet with an average slope of 3.2 %. This reach displays the attributes of a highly unstable Rosgen type “F” channel. A cross section from Reach 2 is depicted in Figure 3-6. Figure 3-7 shows an aerial view of the reach. Figures 3-8 through 3-14 depict typical conditions along Reach 2.

A comprehensive channel design approach utilizing natural channel design principals along the entire of Reach 2 is the recommended approach to stabilizing Reach 2 and protecting infrastructure and private property along the reach. Reach 1 is more stable than Reach 2 and would require less intensive stream restoration efforts, combining it with efforts in Reach 1 would be the most cost effective option. In addition, the comprehensive channel design approach would be eligible to receive credits for TMDL nutrient and sediment reductions.
